# Early Dissociation of a Cemented Constrained Tripolar Acetabular Liner with Fracture of the Locking Ring: A Case Report

**Key words:** Cemented constrained tripolar acetabular liner, complications, constrained acetabular liner, total hip prostheses

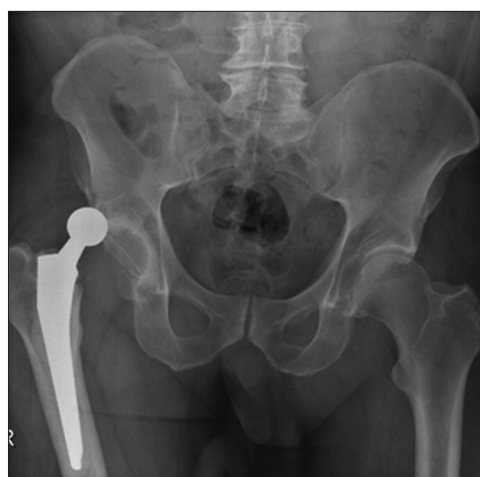
**Figure 1:** Pre-operative radiograph of the pelvis demonstrating a posterosuperior dislocation of the cemented total hip prosthesis (recurrent instability)

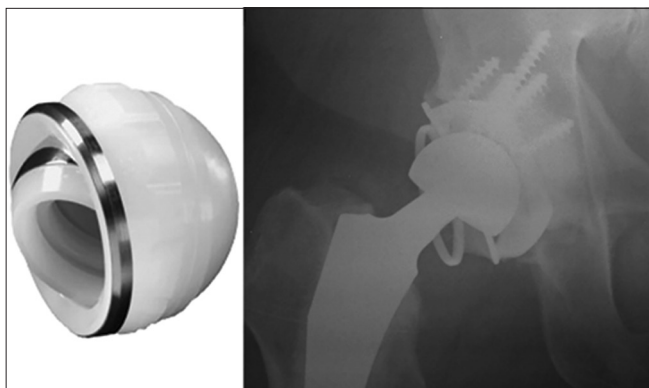
The Stryker Trident<sup>®</sup> constrained acetabular system uses a tripolar constrained liner. The femoral head snaps into an inner polyethylene liner with metal backing, which is free to rotate within an outer polyethylene liner, i.e., an inner bipolar bearing articulating within an outer, true liner [Figure 2].

Post-operative radiograph had been showed malposition of the constrained liner, with an excessive abduction angle [Figure 2]. The patient was allowed to bear weight as tolerated and was scheduled for routine follow-up. Unfortunately, he did not attend to the routine follow-up, and there is no record of any hip radiography performed after the hospitalization period. However, according to the patient the post-operative course was uneventful.

**Figure 2:** Antero-posterior radiograph showing revised construct. After six dislocations, a constrained tripolar acetabular liner was cemented in a metallic support ring. The liner was implanted with an excessive abduction angle

The post-operative radiograph has been showed an excessive inclination of the constrained liner which can originate an impingement against the femoral neck and dissociation of the prosthetic components. Favorable results can be achieved when the abduction angle of the acetabulum is between 35 and 50 degrees and an anteversion angle of between 0 and 20 degrees.<sup>[10]</sup>

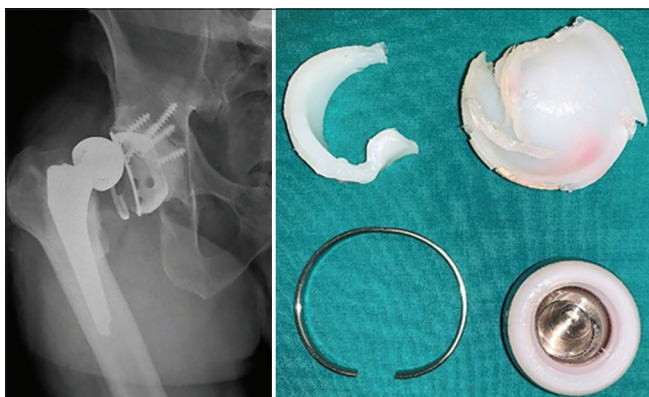
by himself. The event was witnessed by a family member. On examination, the right lower extremity was shortened and internally rotated with limited range of motion secondary to pain. Plain radiographs confirmed posterosuperior dislocation of the bipolar component of the constrained liner and fracture of the locking ring [Figure 3]. Failure had occurred at the bipolar-liner interface (Type III dislocation).

A new revision surgery was performed with the patient in the lateral decubitus position under general anesthesia, and the hip was exposed through a standard posterior approach. Intraoperative inspection of the explanted tripolar liner showed polyethylene damage in the bipolar component and in the rim of the outer liner, including creeps and abrasions, and breakage of the locking ring at 6 O'clock with moderate deformation [Figure 3].

**Figure 3:** Antero-posterior radiograph of the hip showing posterosuperior dislocation of the bipolar component of the constrained liner and fracture of the locking ring. (Type III dislocation), at 2 years and 2 months of follow-up. Macroscopic examination of the retrieval acetabular implant showed locking ring breakage and polyethylene damage in the bipolar component and in the rim of the outer liner

Macroscopic examination of the retrieval acetabular implant showed locking ring breakage and polyethylene damage. These lesions were surely caused by repetitive impingement forces against the femoral neck that occurs with a reduced arc of motion and were favored by malposition of constrained liner.

Dissociation/dislocation of the bipolar interface has been a previously documented complication of constrained liners with breakage or no breakage of the locking ring. We believe that the breakage of the ring has been occurred before and no during the violent hyperflexion adduction maneuver on the hip joint that originated the dissociation of the bipolar interface. Unfortunately, there is no record of any hip radiography performed after the hospitalization period of the first revision surgery.

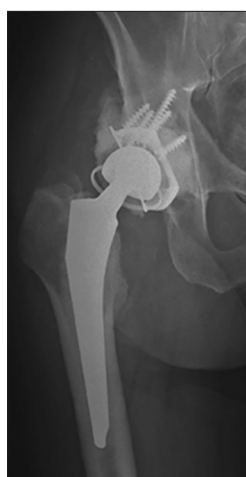
**Figure 4:** Antero-posterior radiograph of the hip after the second revision surgery showing acceptable position of components

result. Post-operative radiograph image of the pelvis showed a favorable orientation of the liner and no signs of instability [Figure 4]. The patient was clinically able to walk without external support.

Revision of the malpositioned component is perhaps the most effective type of surgical intervention in the treatment of dislocation. The liner was removed and a new Trident® constrained tripolar acetabular liner was cemented directly into the metallic support ring, with favorable inclination. We accepted the abduction angle of the metallic support ring; it was moderately high.
